PENNSYLVANIA
HINCKSTON RUN DAM

NDS LD. No. PA - 00430
PENNDER LD. No. 11 - 9

PHASE I INSPECTION REPORT
NATIONAL DAM INSPECTION PROGRAM

GAI CONSULTANTS, INC.
570 BEATTY ROAD
MONROEVILLE, PENNSYLVANIA 15146
SEPTEMBER 1979

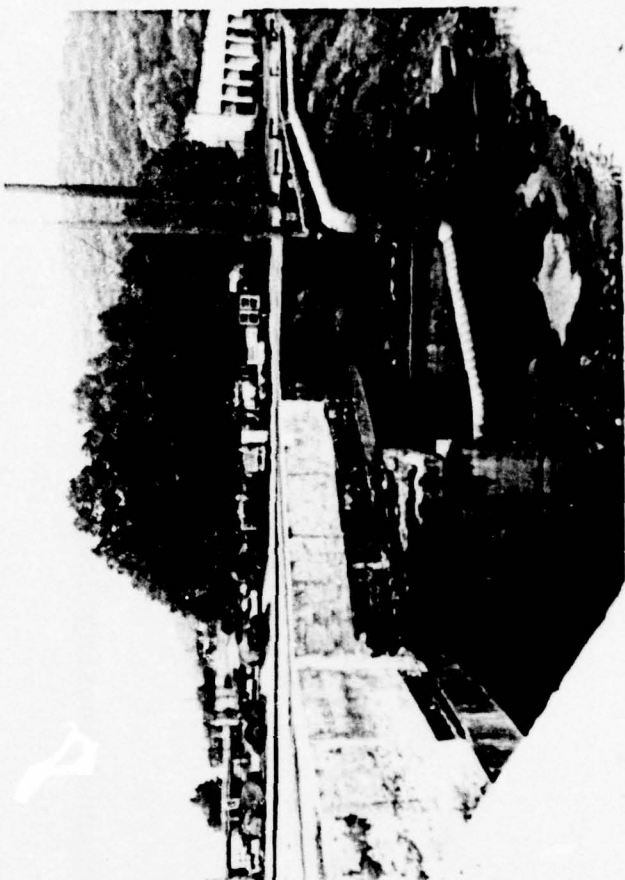
b. Embankment. Visual inspection indicated that the embankment is in good condition (see Photograph 1). The upstream slope is well-aligned and adequately protected by hand-placed sandstone riprap (see Photograph 3). The crest is grass covered and well maintained, and the downstream slope consists of a massive accumulation of dumped hot-poured slag.

PHOTOGRAPH 3 View showing upstream riprap and intake tower.

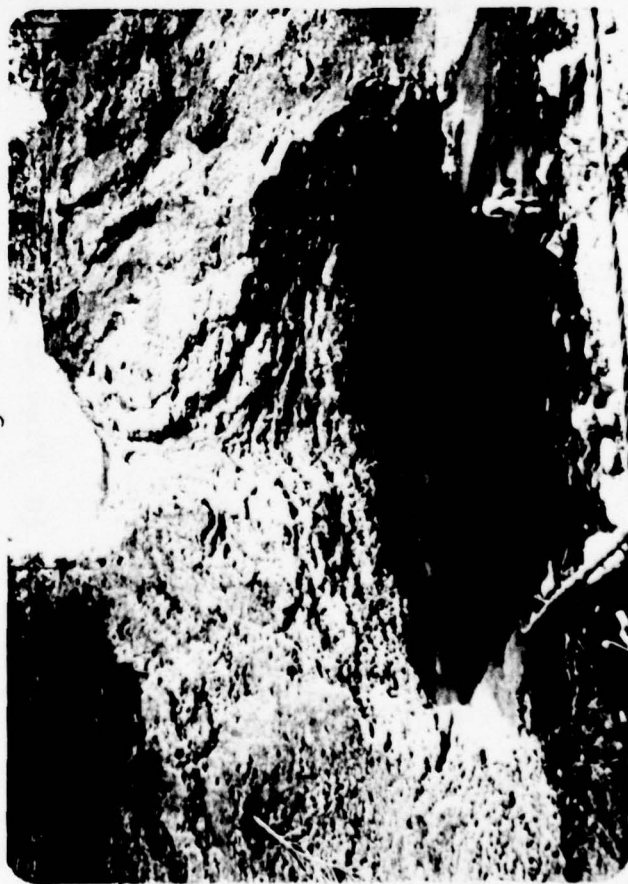
2. Outlet Works. The intake tower and valve house were observed to be in good condition (see Photographs 3 and 8). The blowoff line was operated from within the valve house during inspection via an electrical valve mechanism (see Photographs 10 and 11). Valves in the intake tower are reportedly opened and probably inoperable. The owner's representatives also indicated that some modifications have been made to the intake system within the tower (no as-built drawings are available).

PHOTOGRAPH 8 View of valve house and adjoining water treatment structure from embankment crest.

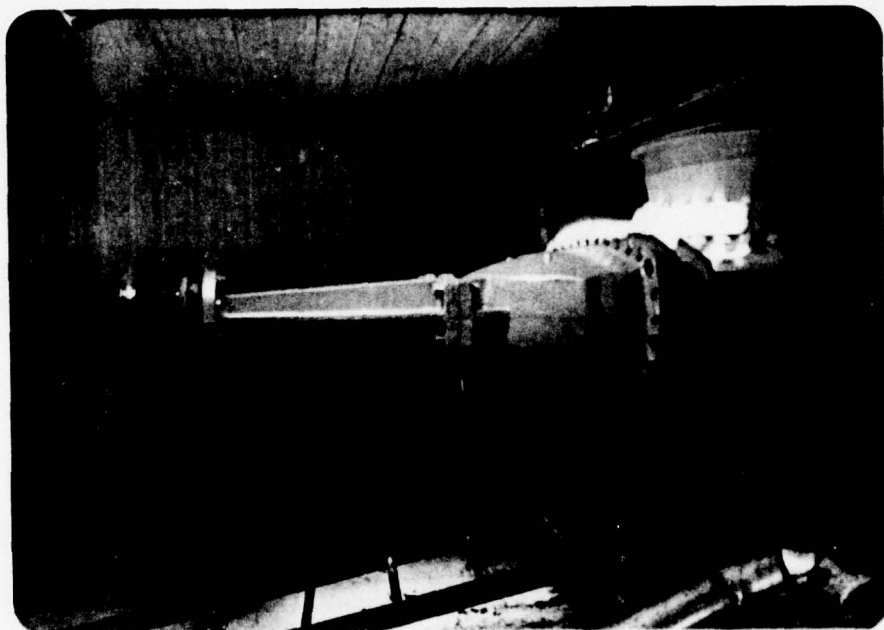
PHOTOGRAPH 11 View of blowoff in operation.
